6  
**EXPERIMENTAL IMAGE COMPRESSION  
SUBSYSTEM (EICS) COMMUNICATION  
TESTING**

**ROME AIR DEVELOPMENT CENTER  
Air Force Systems Command  
Griffiss Air Force Base, New York 13441**

## EICS COMMUNICATION TESTING

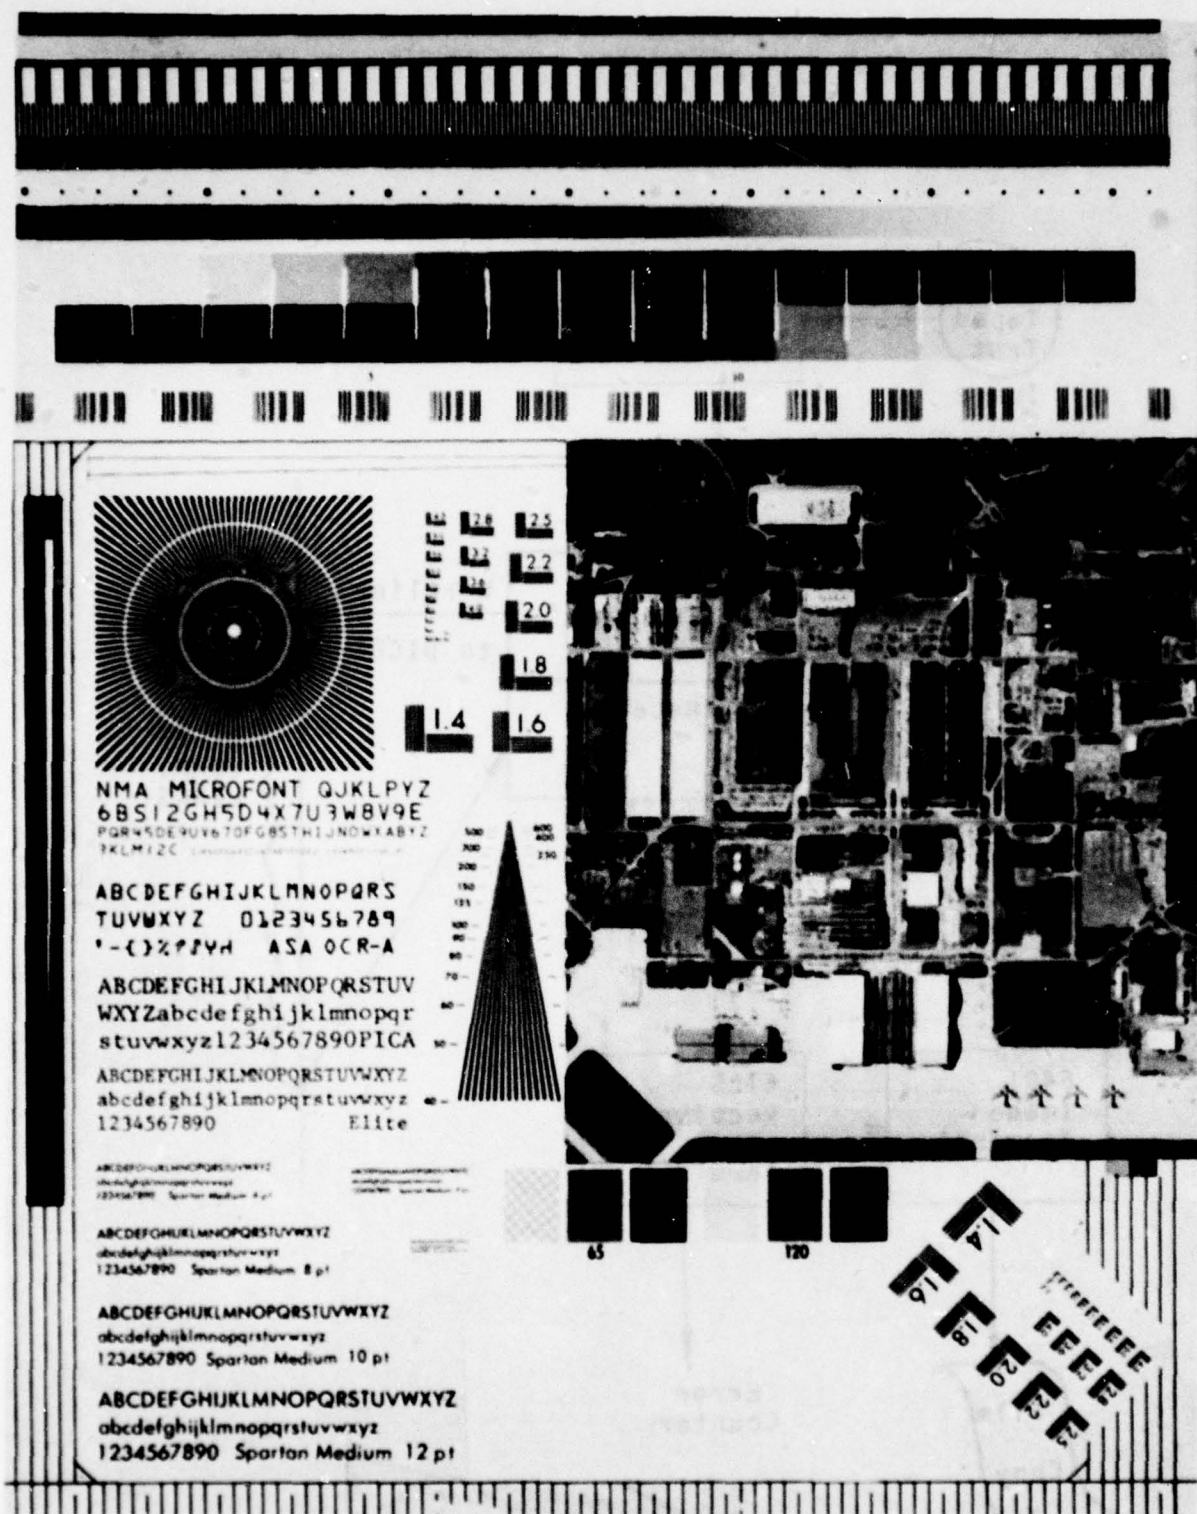
Figure 1 Test Pattern Original

The tests used a specially prepared input image, Figure 1 which provided subjective and quantitative evaluation of the effects of various communication links. Some tests also demonstrated the redundant area coding<sup>1</sup> (REARCS) scheme. (See

The test included two image subjects, one a standardize IEEE test pattern and a representative aerial recon photo. The test pattern provided a good quantitative measure of system performance while the aerial provided a subjective evaluation. The two subjects were pieced together to make a full size 8 x 8 inch composite photo as shown in Figure 1. A typical reconnaissance image was also used to demonstrate the REARCS<sup>1</sup> (see Photos 12 and 14). The composite photo was used for all transmissions, except Photos 12 and 14.

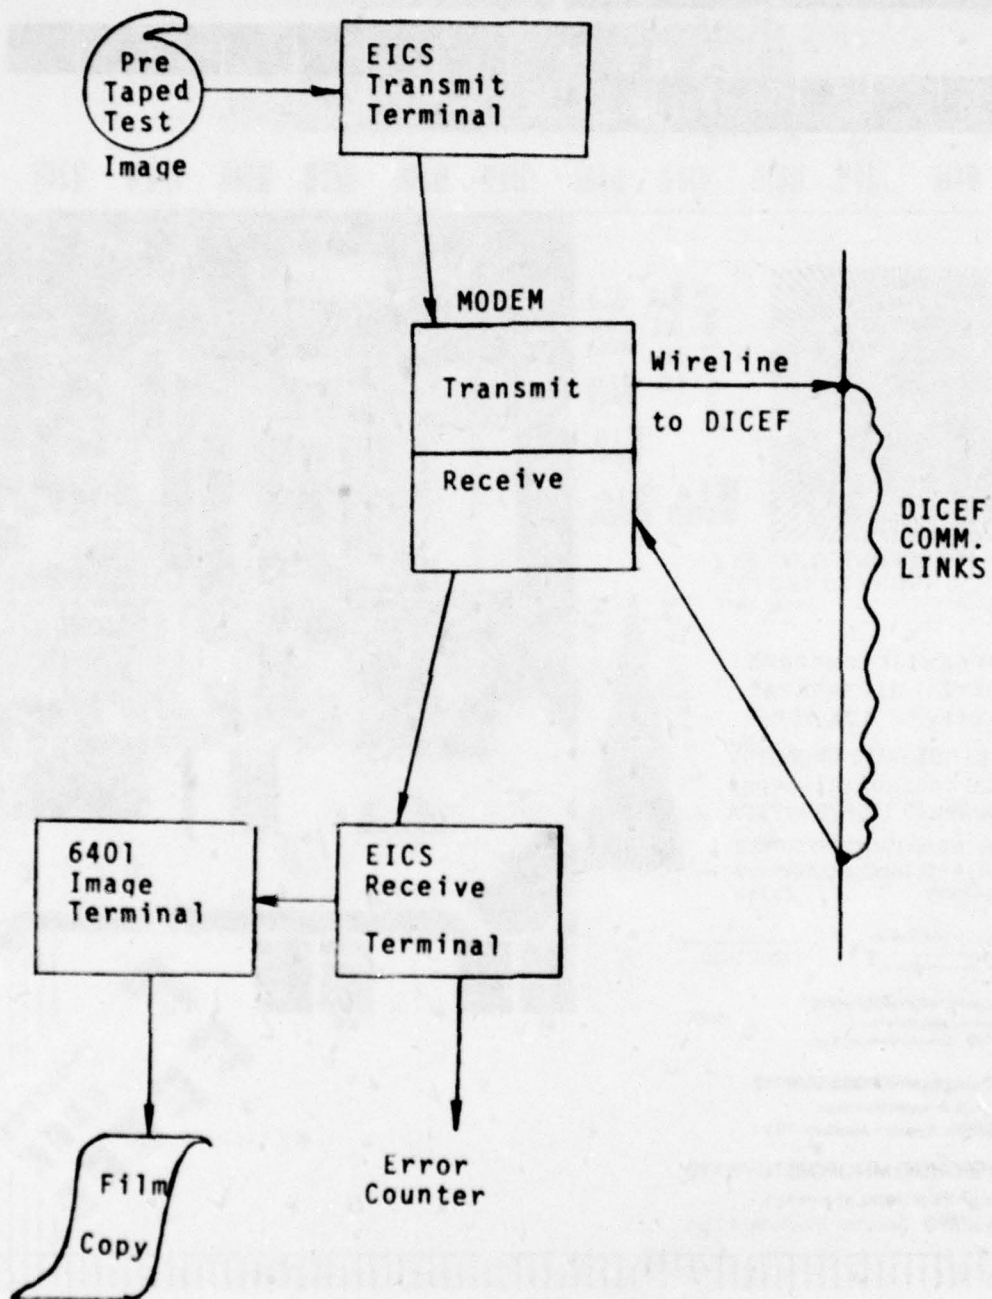
Figure 2 Real Time Communications Channel Test

time over those link combinations using the EICS system as shown in Figure 2.

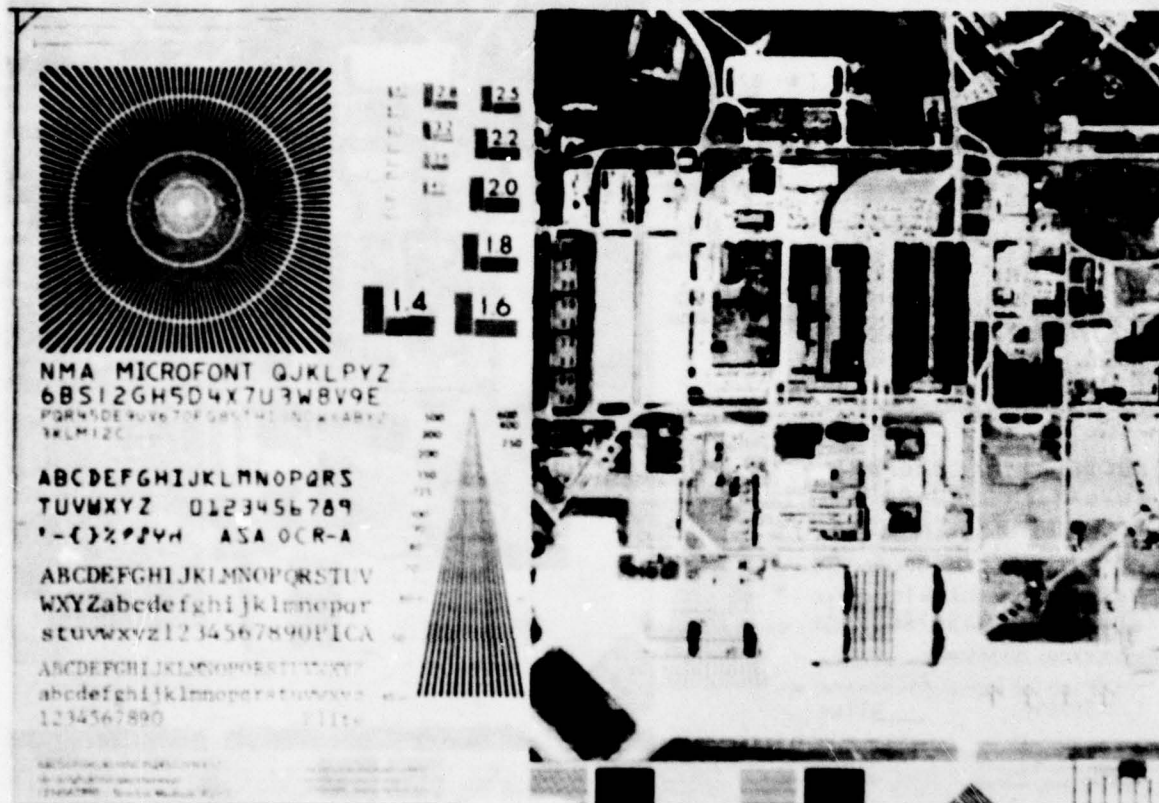
PHOTO 1  
STD Telephone Wire Line

Photo #1 was transmitted over standard telephone line at a data rate of 9600 bps with a predetermined measured bit error rate of  $.6 \times 10^{-4}$ . The signal to noise ratio of the

telephone line was 22.5 db. The Pestrecov Star located at center left side is a good area of reference for evaluation of image distortion. Some image distortion can be seen, however, the reconnaissance image area is still usable.

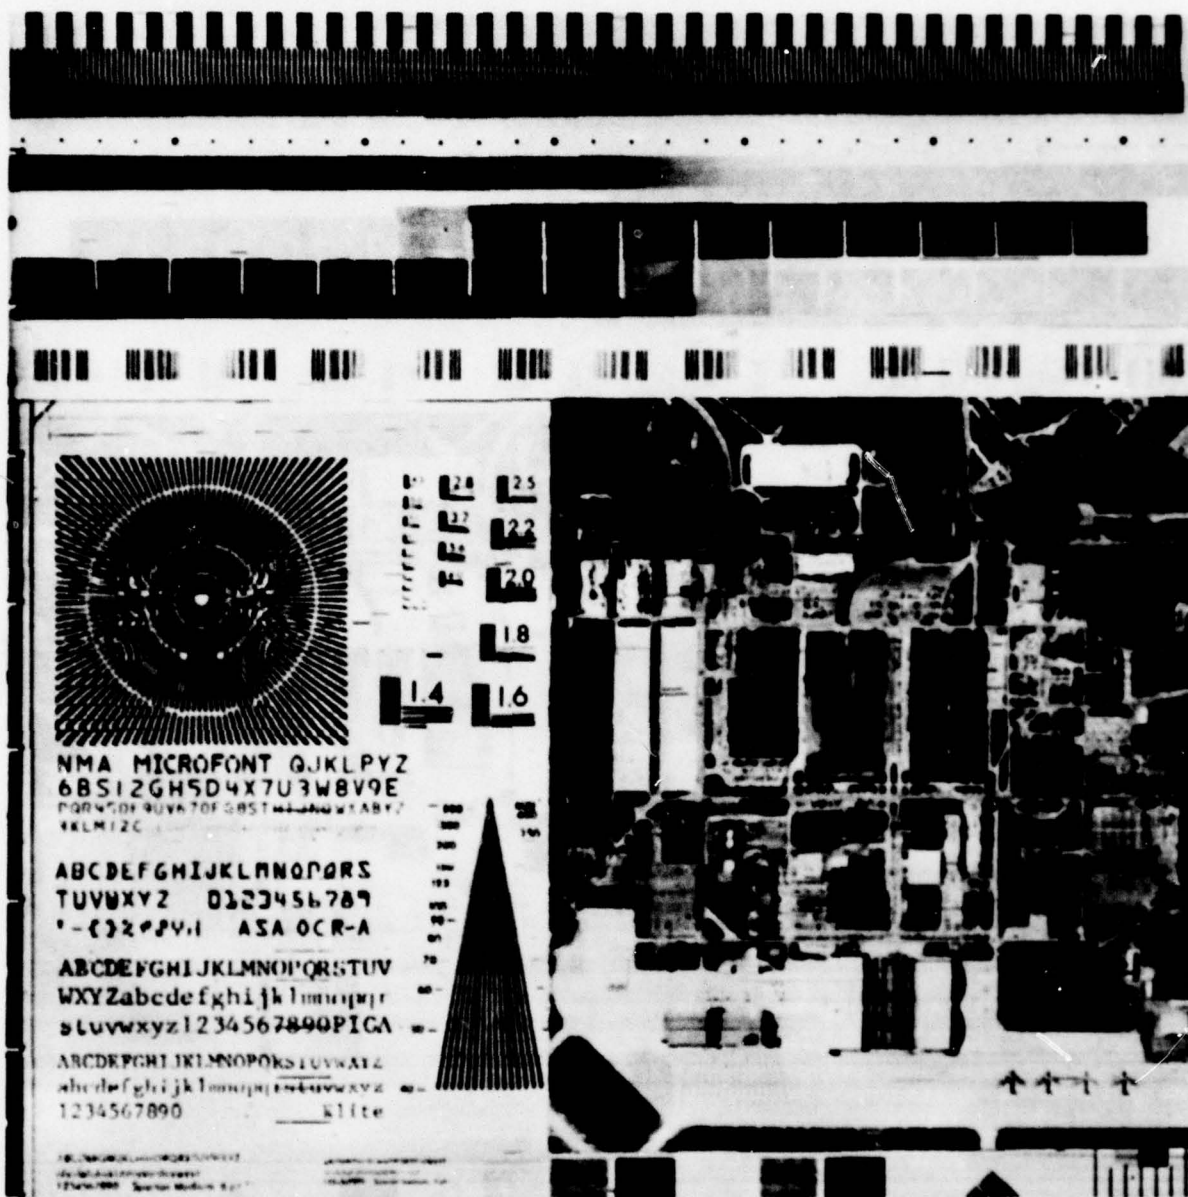
PHOTO 2  
 STD Telephone Wire Line

Photo #2 was transmitted over standard telephone line at a data rate of 9600 bps with a predetermined measured bit error rate of  $1.25 \times 10^{-3}$ . The signal to noise ratio of the telephone line was 19.0 db. Review of the Pestrecov Star area shows a high degree of distortion compared to Photo #1. The reconnaissance image area is still highly usable.

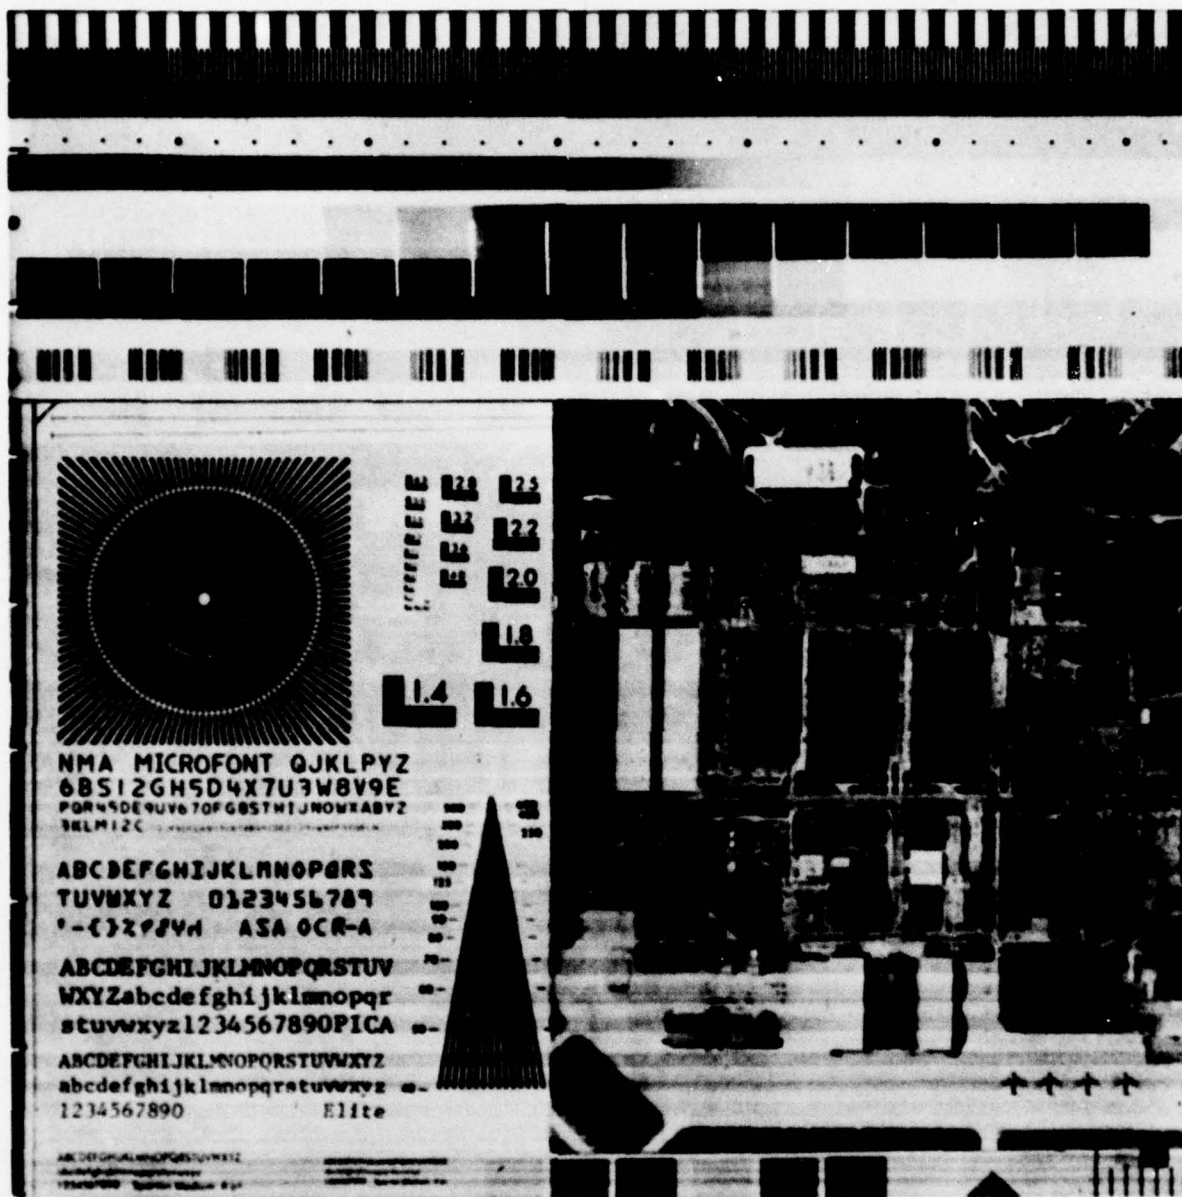
PHOTO 5  
AUTOVON TESTING

Photo #5 was transmitted over an Autovon line between RADC, Rome, N.Y. and Tully, N.Y. and back to RADC at a data rate of 4300 bps. The signal level was -16db out and -10db

in, and had a bit error rate of  $1 \times 10^{-6}$ . There were no noticeable distortions in the Pestrecov Star. The transmission time was 55 minutes, with no image compression.

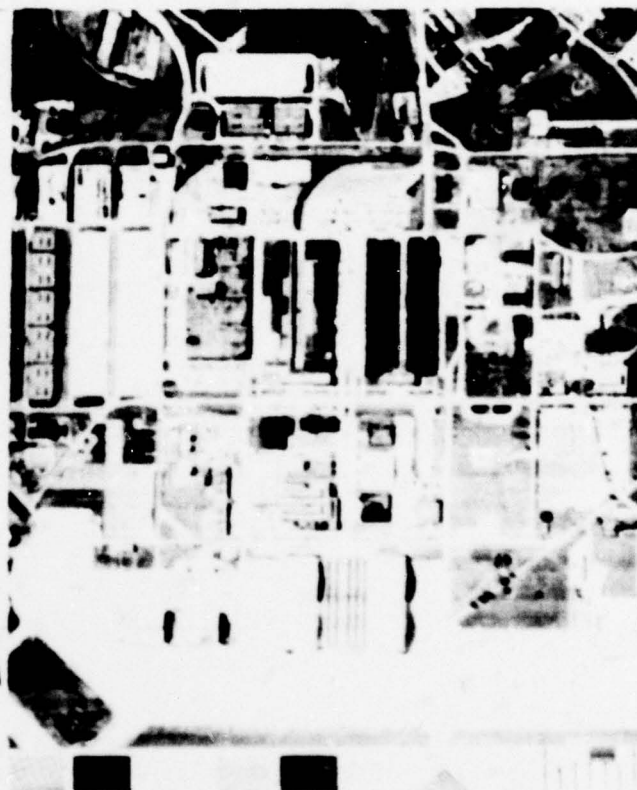
PHOTO 8  
AUTOVON TESTING

Photo #8 was transmitted over an Autovon line between four links, and the data rate was 9600 bps. The signal was -11db out and -9db in and had a bit error rate of  $1.1 \times 10^{-4}$ . Image evaluation of photo #8 shows little or no distortion of the Pestrecov Star. Transmit time was approximately twenty-five minutes.

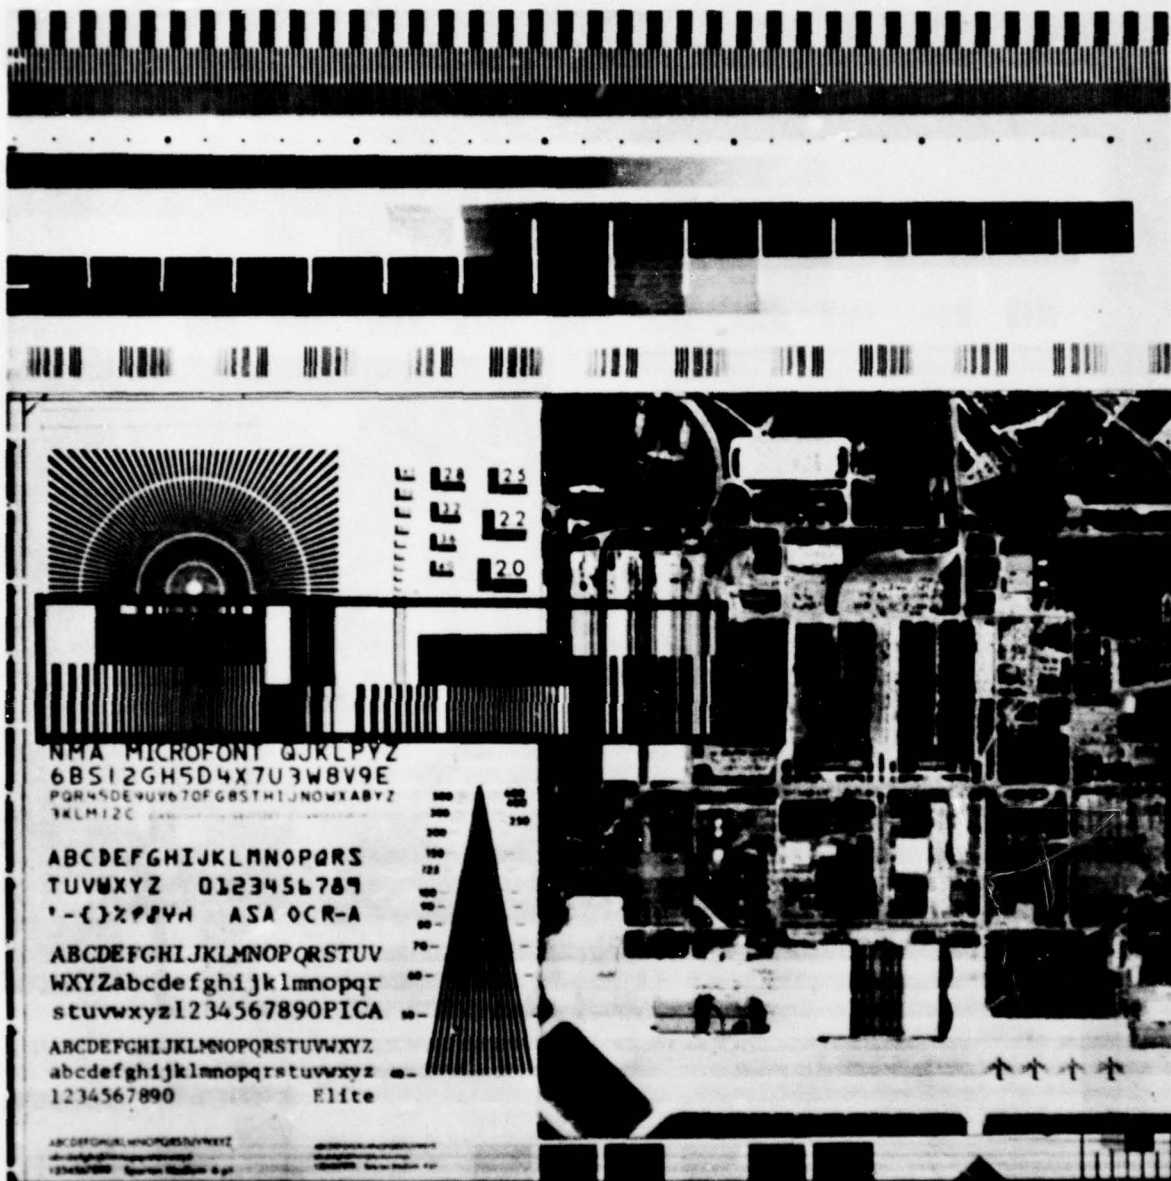
PHOTO 10  
 AUTOVON TESTING

Photo #10 was transmitted over an Autovon line with five links, however, the data rate was reduced from 9600 bps to 7200 bps. The signal was -11db out and -12.5db in and had a

bit error rate of  $1.1 \times 10^{-4}$ .

Lowering of the data rate allowed for a successful transmission. The outlined area designated a programming error, and shows its result on the image.

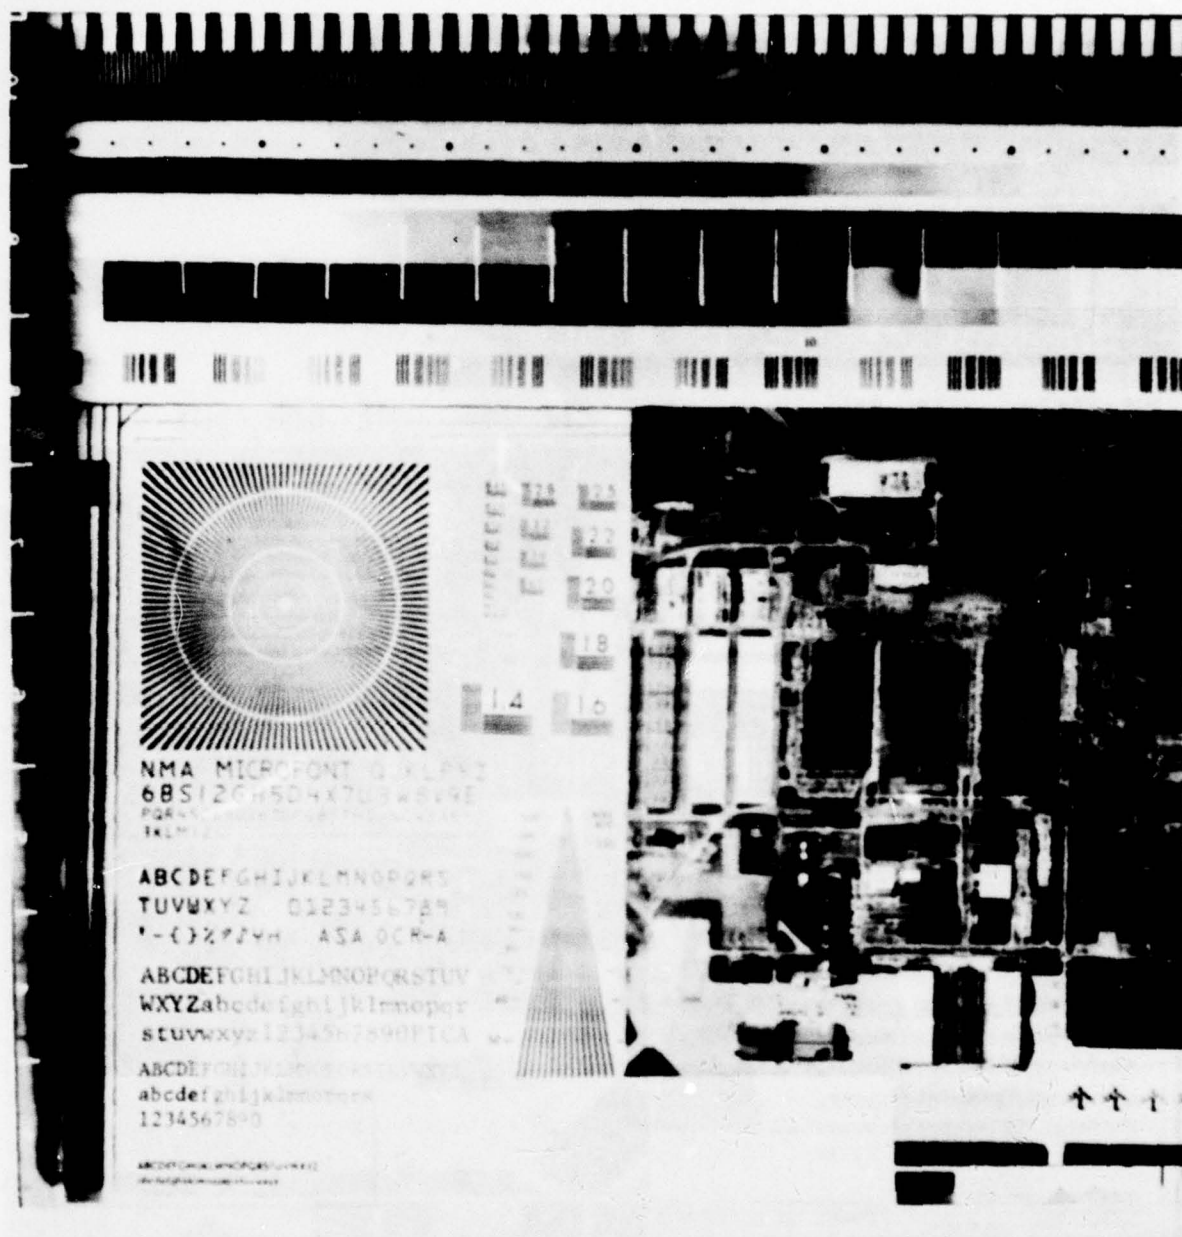
PHOTO 11  
MICROWAVE 2 LINK

Photo #11 was transmitted over Microwave between two links, and the data rate was 9600 bps. The bit error rate was  $1 \times 10^{-5}$ . The Pestrecov Star shows some distortion, however; the reconnaissance image is not affected by the distortion and is considered good image quality.

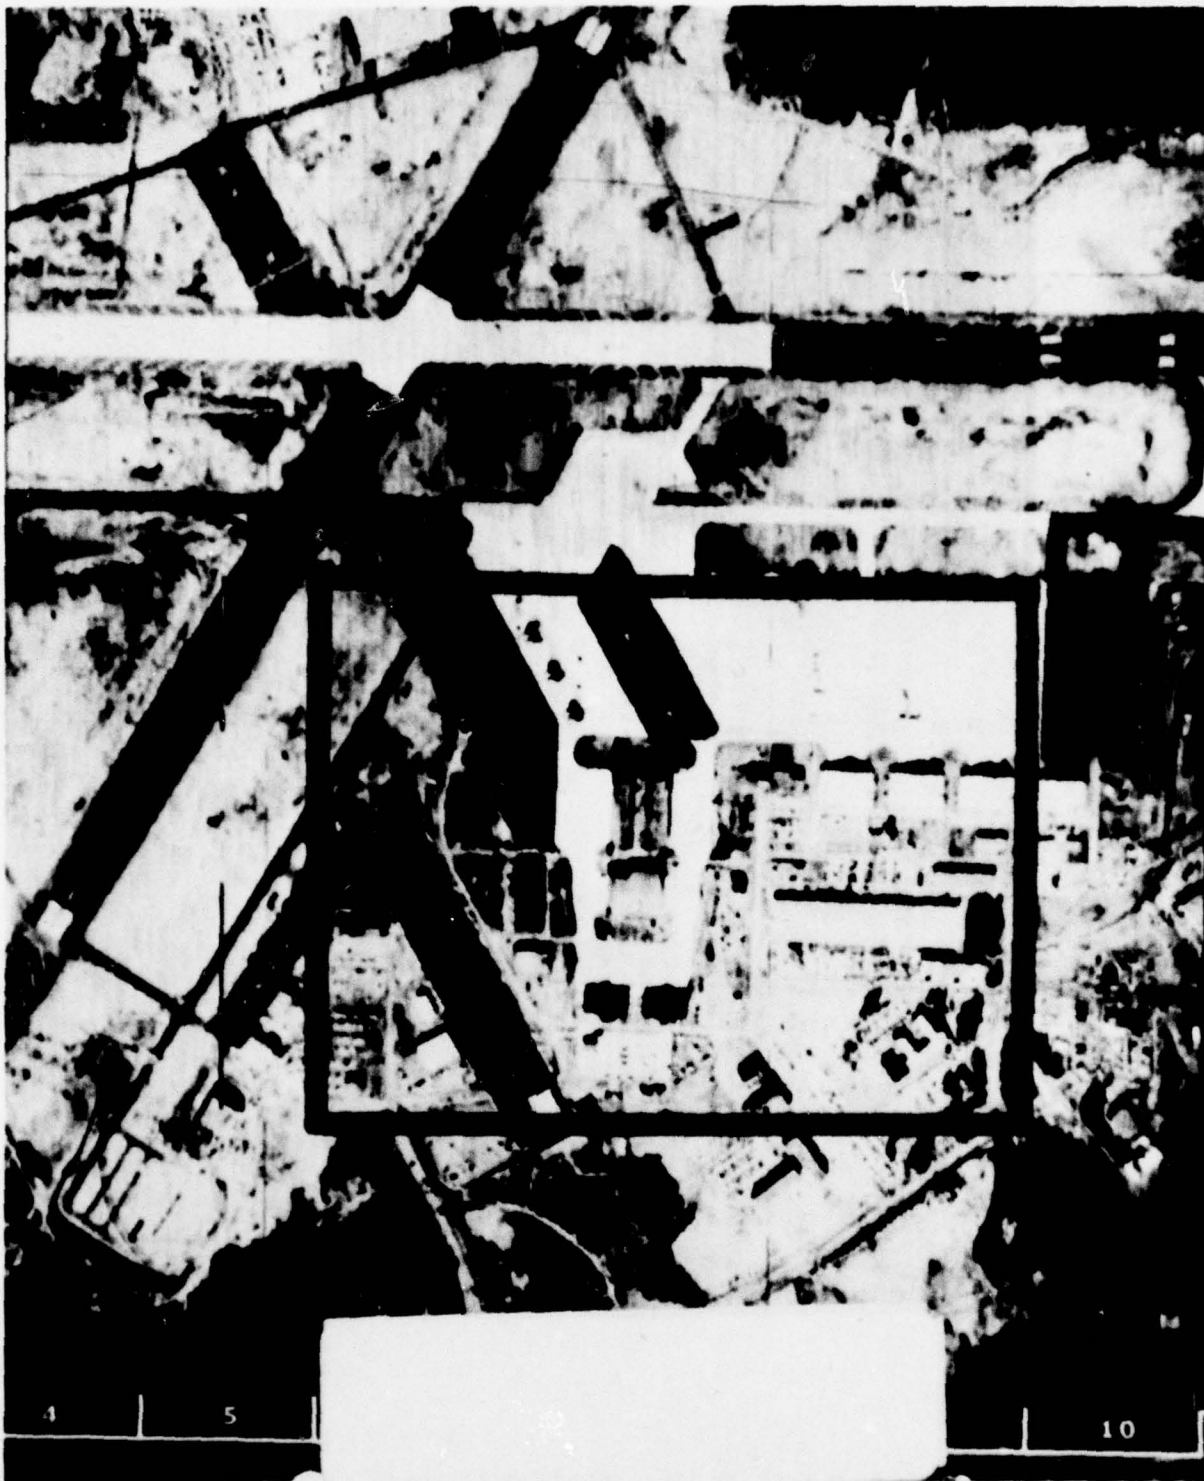
PHOTO 14

Photo #14 was transmitted over Tropo with two hops at a data rate of 4800 bps. Lowering the data rate allowed for a successful transmission. This photo also utilized the REARCS scheme. The area outlined represents the area of high interest

and therefore was transmitted at full resolution. Transmission and reception time was approximately fourteen minutes for the full 8" x 8" photo.

Only two photos were transmitted over troposcatter. More time was spent on tropo transmission than any other. The tropo equipment transmitted only the EICS imagery, and therefore it is not considered a true test, where the tropo equipment would be loaded down with other voice transmissions. Of the two images transmitted, only the 4800 data rate image was successful. The 9600 data rate proved to be too high.
